PRELIMINARY GEOTECHNICAL INVESTIGATION

Hedley, Gelliondale, Alberton (HGA) Wind Farm, South Gippsland, Victoria

Report Number. 1666035-001-R-Rev1

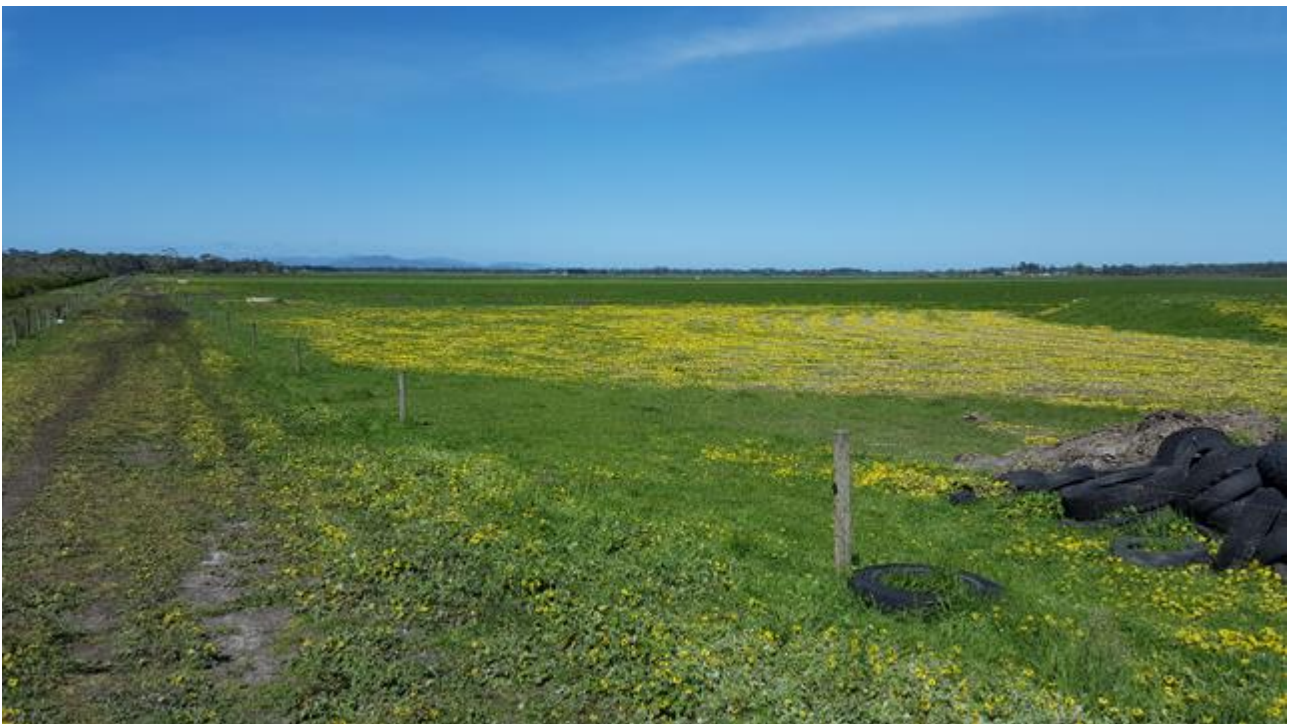
Photograph 1: Looking in a southerly direction towards T05 and T04 locations from just east of T06 location

The subsurface materials encountered in Test Pit TP1 located near the proposed T02 comprised high plasticity clay ranging from firm to stiff consistency to the maximum investigation depth of 2.7 m. Sandy silty clay (topsoil) was encountered to 0.2 m depth. Groundwater was encountered at 2.4 m depth.

Photograph 1 below shows the ground surface condition looking in a southerly direction towards the proposed T05 and T04 locations from just east of the proposed T06 location.

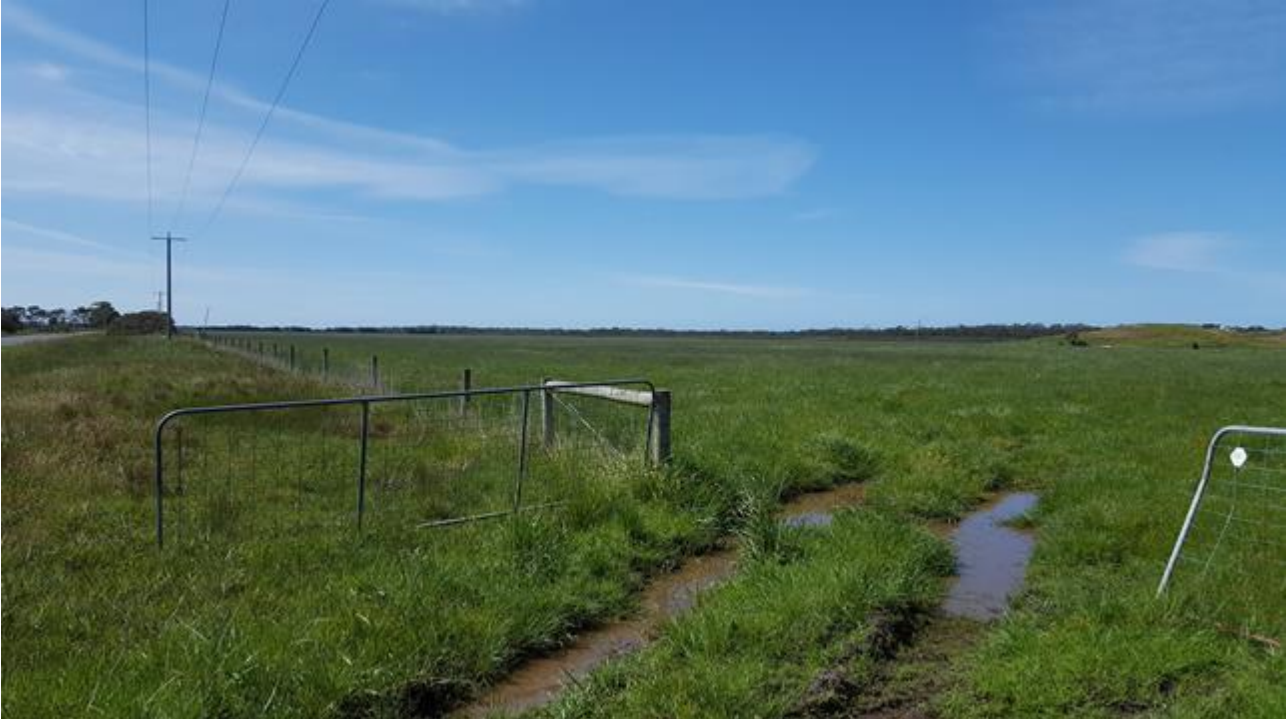
Photograph 2: Looking in a southerly direction towards T10 and T11 from South Gippsland Highway and Coal Mine Road Intersection

Some surface water ponding was present at the time of our site visit as shown in Photograph 2. Site observations suggest that the proposed T08 location could be positioned in a low lying marsh type feature. Vehicle access to near this site was not possible during the site visit due to wet ground surface conditions.

The subsurface materials encountered in Test Pit TP3 located near the proposed T10 and T11 comprised high plasticity clay of mostly firm consistency to the maximum investigation depth of 2.6 m. Sandy silty clay (topsoil) was encountered to 0.2 m depth. Groundwater was encountered at 1.9 m depth.

Photograph 2 below shows the ground surface condition looking in a southerly direction towards the proposed T10 and T11 locations from the South Gippsland Highway and Coal Mine Road intersection.

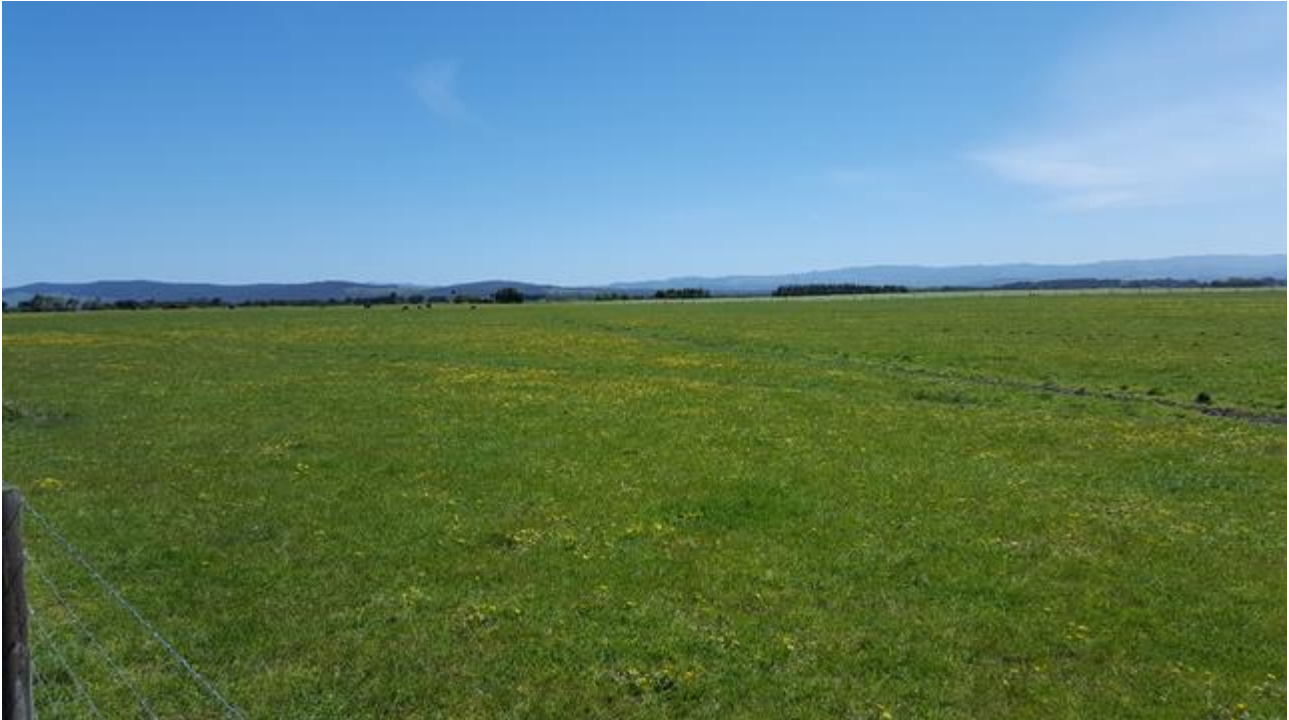
Photograph 3: Looking in a westerly direction towards T18 and T22 from northern boundary of Gelliondale State Forest and Ti Tree Road

No evidence of slope instability was observed in this zone. The ground surface was observed to become wetter to the south.

Photograph 3 below shows the ground surface condition looking in a westerly direction towards the proposed T18 and T22 locations from the intersection of the northern boundary of Gelliondale State Forest and Ti Tree Road.

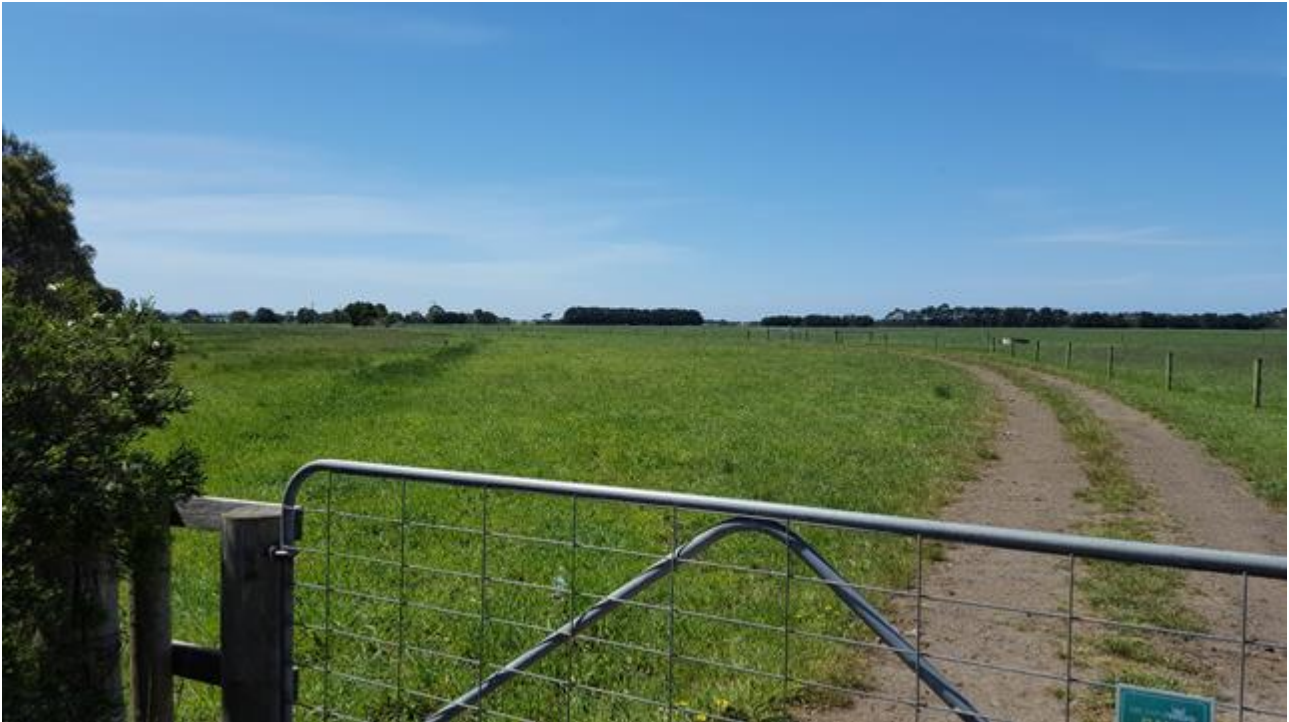
Photograph 4: Looking in a north easterly direction towards WTG T25 from gate off Old Alberton Drive

No groundwater was observed in Test Pit TP6.

Photograph 4 below shows the ground surface condition looking in a north easterly direction towards the proposed T25 location from the entrance gate off Old Alberton Drive.

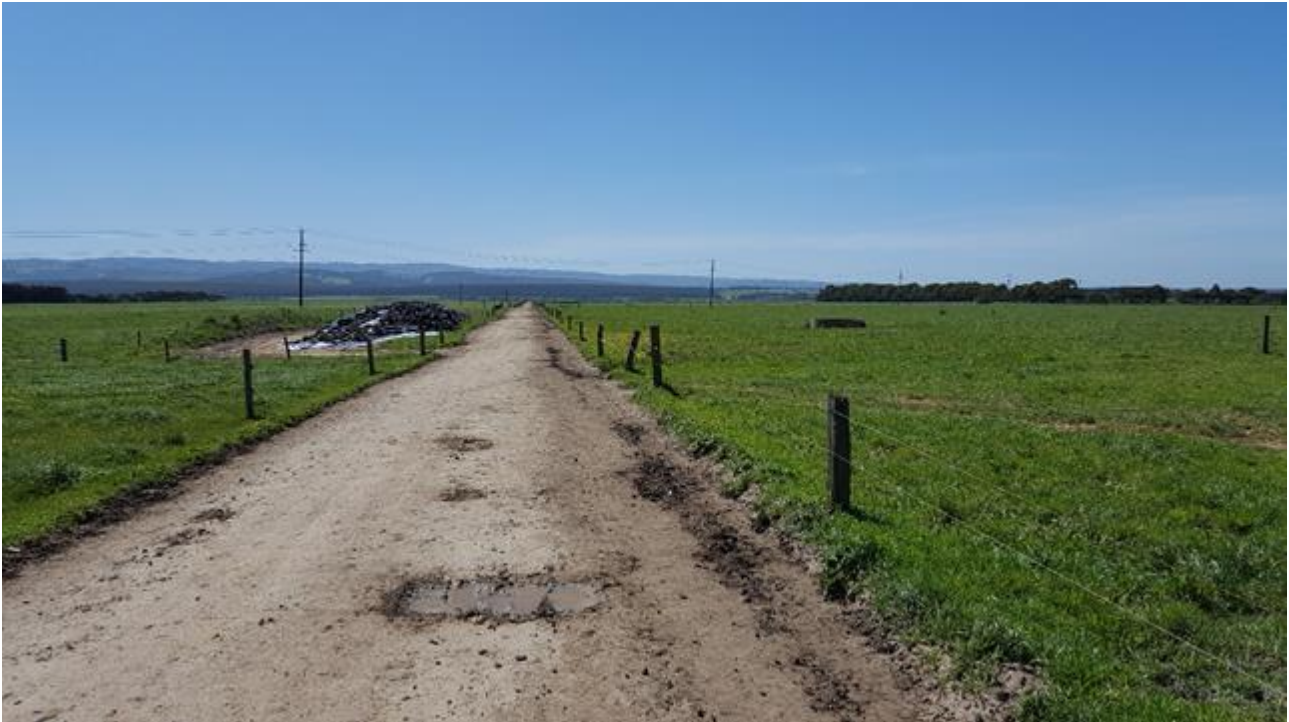
Photograph 5: Looking in a north direction towards T20, T21 and T23 from private access road

The area is currently agricultural land used for livestock and possible cropping. The proposed northern most T21 and T23 locations were not accessible with a vehicle during the site visit due to the presence of saturated and 'boggy' ground surface conditions. These proposed wind turbine positions are located in a lower lying area of the site.

No groundwater was encountered in Test Pit TP7.

Photograph 5 below shows the ground surface condition looking in a north direction towards the proposed T20, T21 and T23 locations from a private access road.

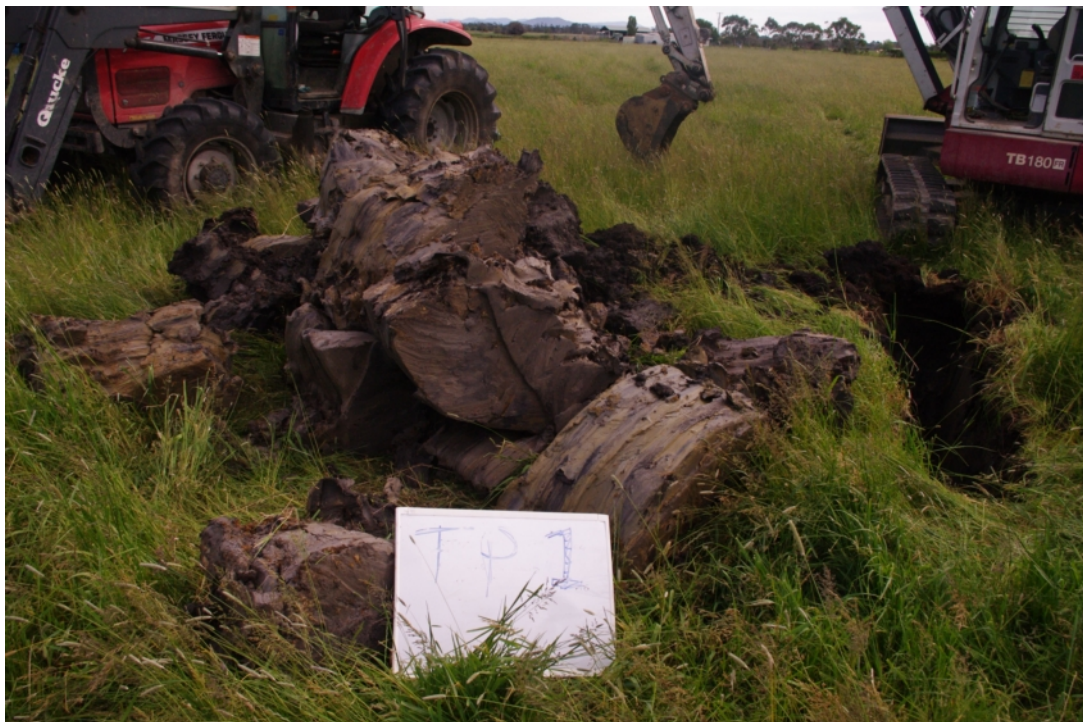
POSITION: Birds Road South
 COORDS: 458631 m E 5722033 m N MGA94 56 (hhGPS)
 SURFACE RL: DATUM: AHD
 LENGTH: 3.00 m WIDTH: 0.45 m
 PIT DEPTH: 2.70 m
 BUCKET TYPE: 450 mm

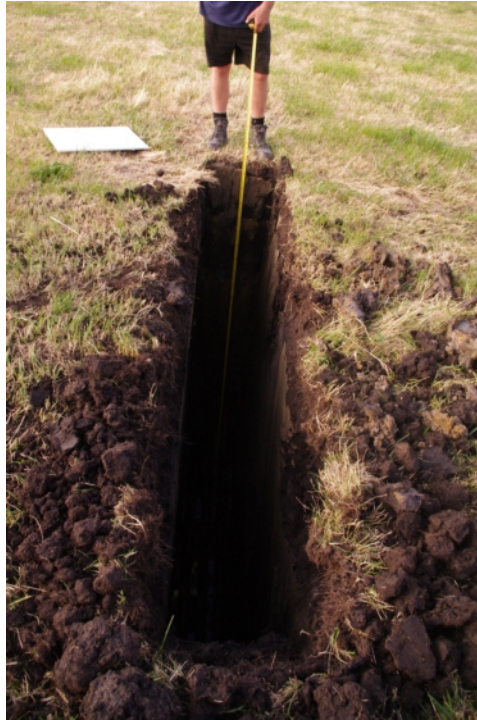
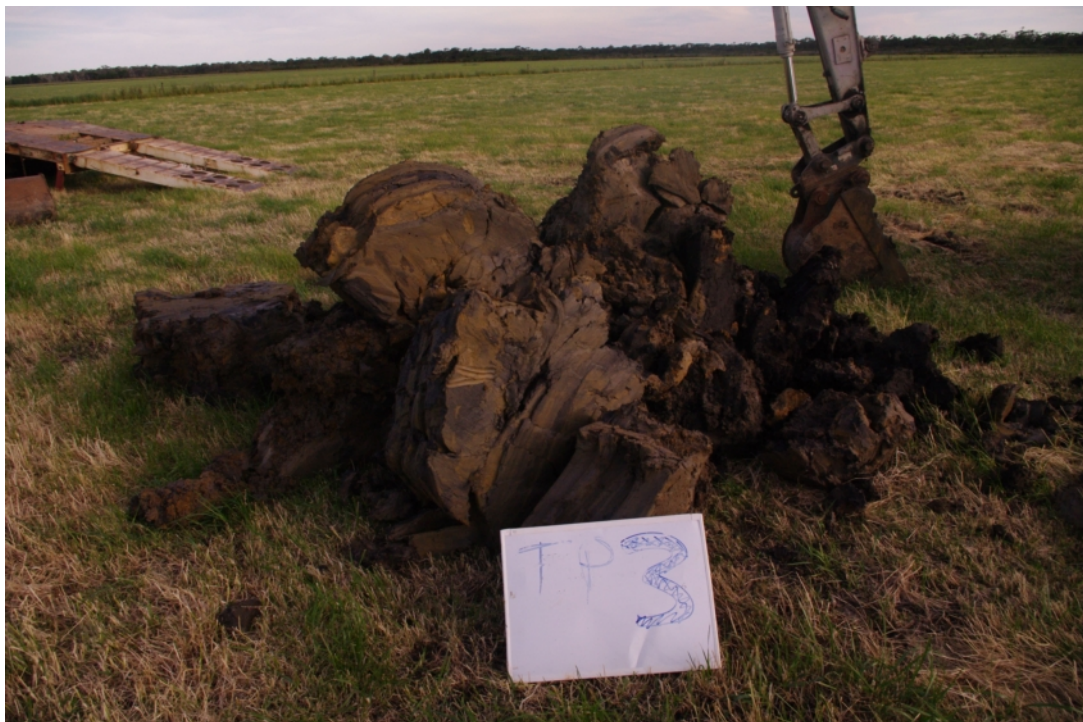
Excavation			Sampling		Field Material Description														
METHOD	EXCAVATION RESISTANCE	WATER	DEPTH (metres)	DEPTH RL	SAMPLE OR FIELD TEST	RECOVERED GRAPHIC LOG	USCS SYMBOL	SOIL/ROCK MATERIAL DESCRIPTION	MOISTURE CONDITION	CONSISTENCY DENSITY	STRUCTURE AND ADDITIONAL OBSERVATIONS	DCP TEST (AS1289.6.3.2) Blows per 100 mm							
												0	5	10	15	20	25		
EX	M		0.0				CH	Sandy Silty CLAY high plasticity, dark grey, fine sand	M (c PL)		rootlets and organics near surface								
			0.20			CH	CLAY high plasticity, dark grey	F - St											
			0.50	0.50 m PP = 100 kPa															
			1.00	1.00 m PP = 100 kPa					grey and orange	M (>PL)									
			1.50						F										
			2.00		2.00 m PP = 50 kPa				W										
			2.50																
			3.00					TEST PIT DISCONTINUED @ 2.60 m TARGET DEPTH GROUNDWATER ENCOUNTERED @ 1.90 m DEPTH BACKFILLED

POSITION: South Gippsland Hwy
 COORDS: 462825 m E 5723740 m N MGA94 56 (hhGPS)
 SURFACE RL: DATUM: AHD
 LENGTH: 3.00 m WIDTH: 0.50 m
 PIT DEPTH: 2.60 m
 BUCKET TYPE: 450 mm

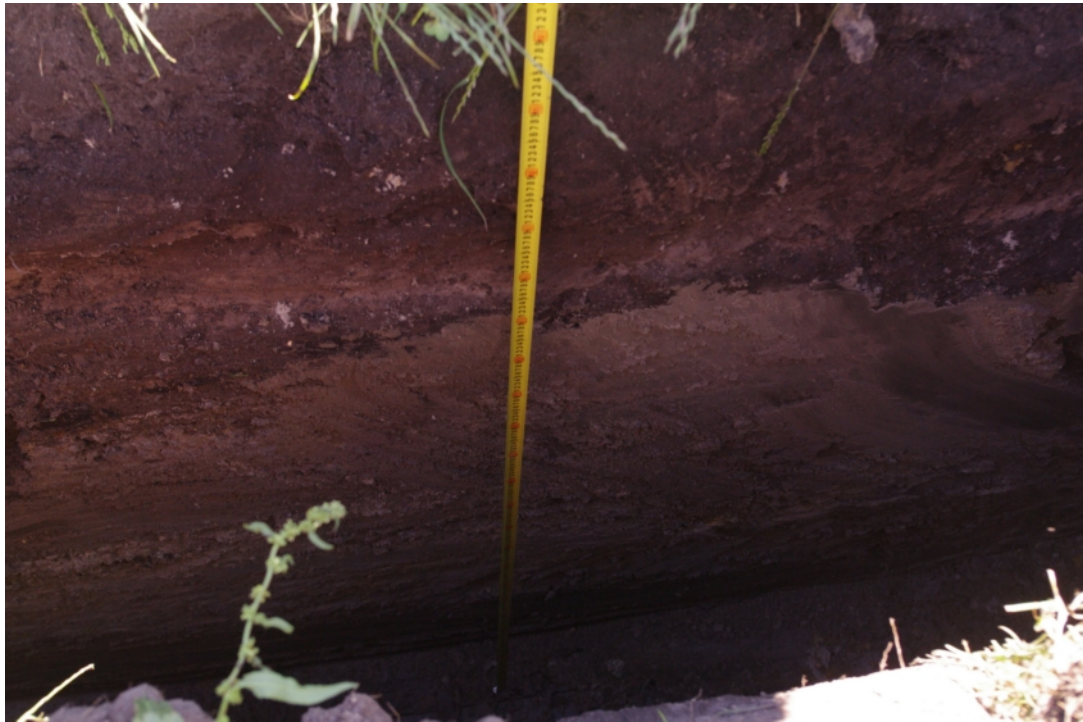
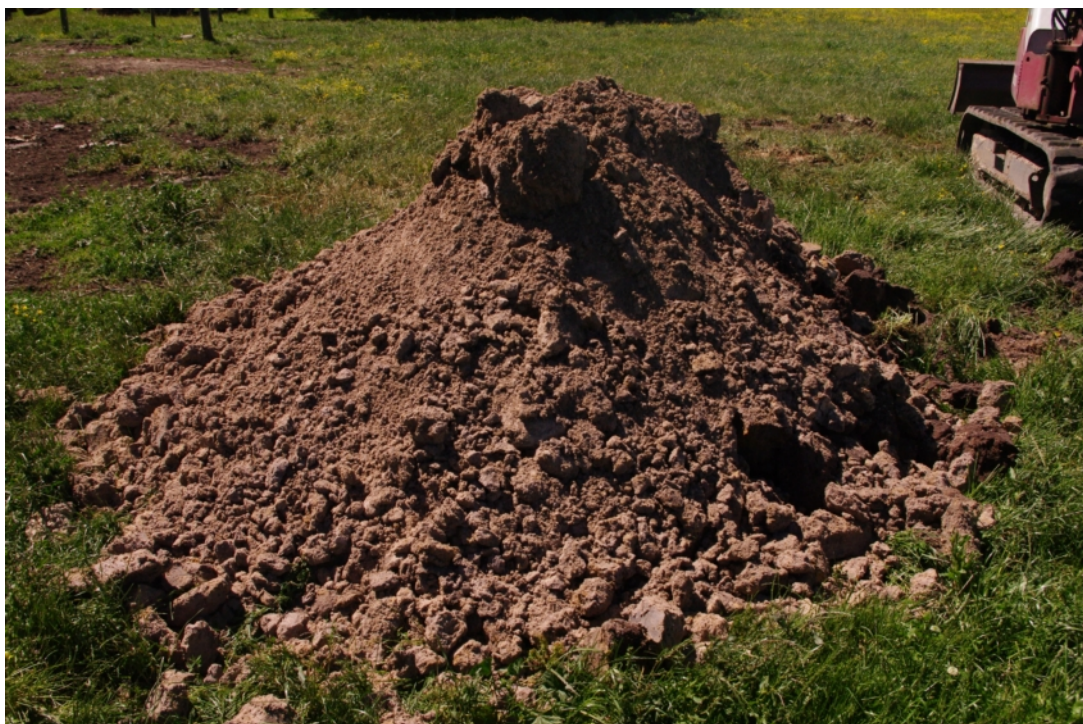
2.5					TEST PIT DISCONTINUED @ 2.50 m TARGET DEPTH GROUNDWATER NOT OBSERVED BACKFILLED									
			3.0

POSITION: South Gippsland Hwy
 COORDS: 466154 m E 5723370 m N MGA94 56 (hhGPS)
 SURFACE RL: DATUM: AHD
 LENGTH: 3.00 m WIDTH: 0.50 m
 PIT DEPTH: 2.50 m
 BUCKET TYPE: 450 mm

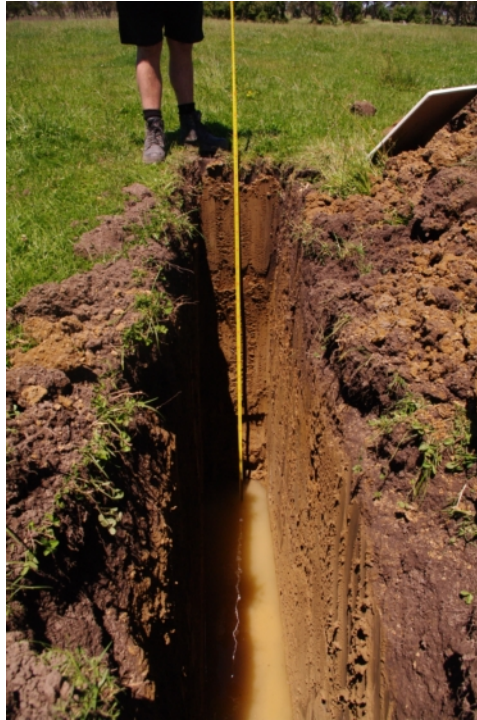
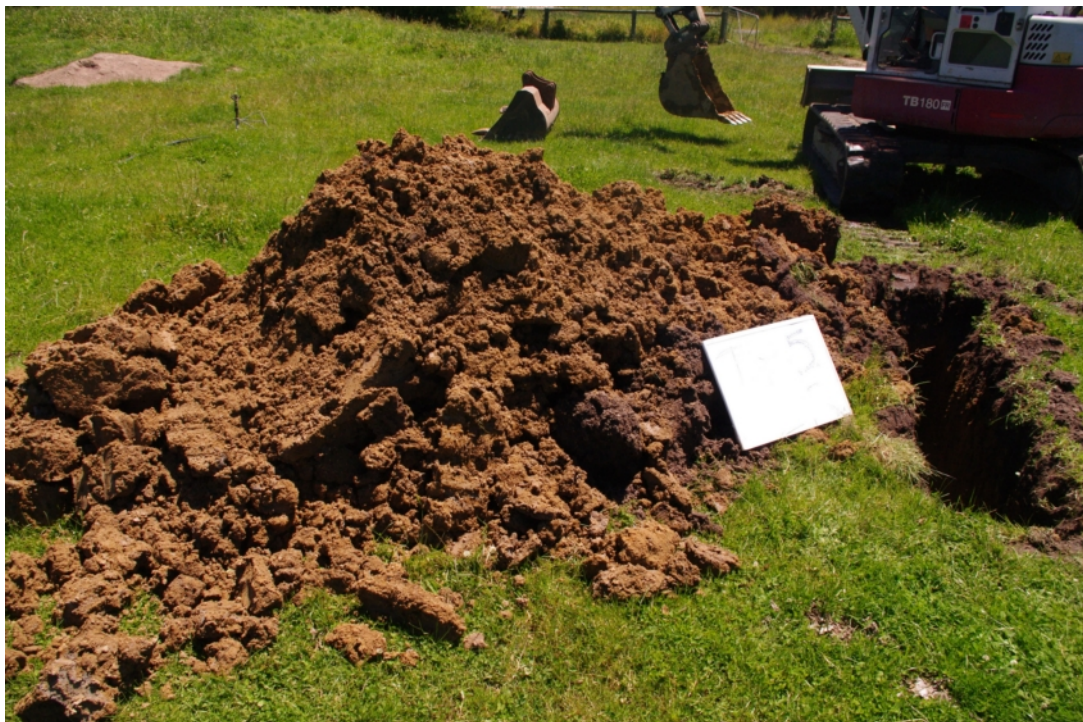
POSITION: Ti Tree Road
 COORDS: 468816 m E 5724475 m N MGA94 56 (hhGPS)
 SURFACE RL: DATUM: AHD
 LENGTH: 3.00 m WIDTH: 0.50 m
 PIT DEPTH: 2.60 m
 BUCKET TYPE: 450 mm

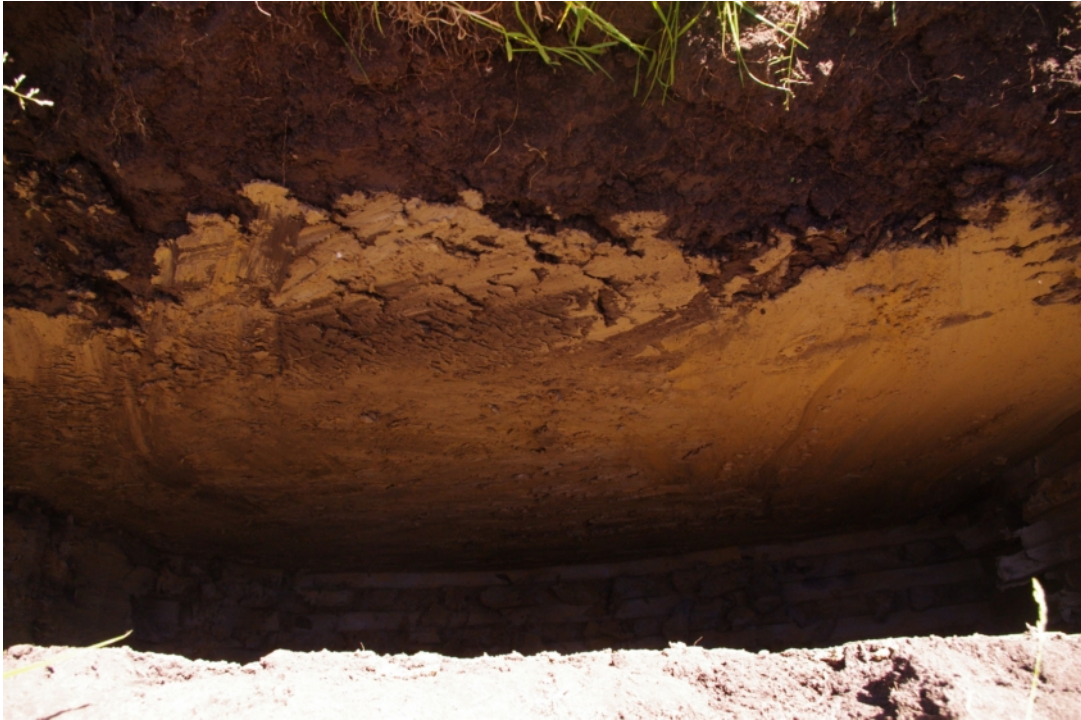
Excavation			Sampling		Field Material Description														
METHOD	EXCAVATION RESISTANCE	WATER	DEPTH (metres)	DEPTH RL	SAMPLE OR FIELD TEST	RECOVERED GRAPHIC LOG	USCS SYMBOL	SOIL/ROCK MATERIAL DESCRIPTION	MOISTURE CONDITION	CONSISTENCY DENSITY	STRUCTURE AND ADDITIONAL OBSERVATIONS	DCP TEST (AS1289.6.3.2) Blows per 100 mm							
												0	5	10	15	20	25		
EX	M		0.0				CH	Sandy Silty CLAY high plasticity, dark grey, fine sand	M(c PL)		rootlets and organics near surface								
			0.30				CH	CLAY high plasticity, dark grey	M(c PL)										
			0.60		0.40 m PP = 250 kPa				pale grey and orange										
			1.50		0.80 m PP = 150 kPa														
			2.00		1.50 m PP = 200 kPa				M(>PL)										
			2.50		2.00 m PP = 150 kPa			TEST PIT DISCONTINUED @ 2.50 m TARGET DEPTH GROUNDWATER NOT OBSERVED BACKFILLED											
			3.00

POSITION: Old Alberton West Road
 COORDS: 466479 m E 5726274 m N MGA94 56 (hhGPS)
 SURFACE RL: DATUM: AHD
 LENGTH: 3.00 m WIDTH: 0.50 m
 PIT DEPTH: 2.50 m
 BUCKET TYPE: 450 mm

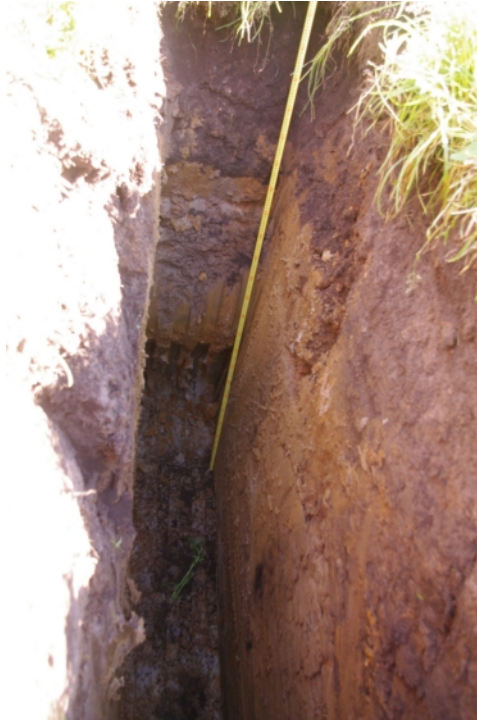
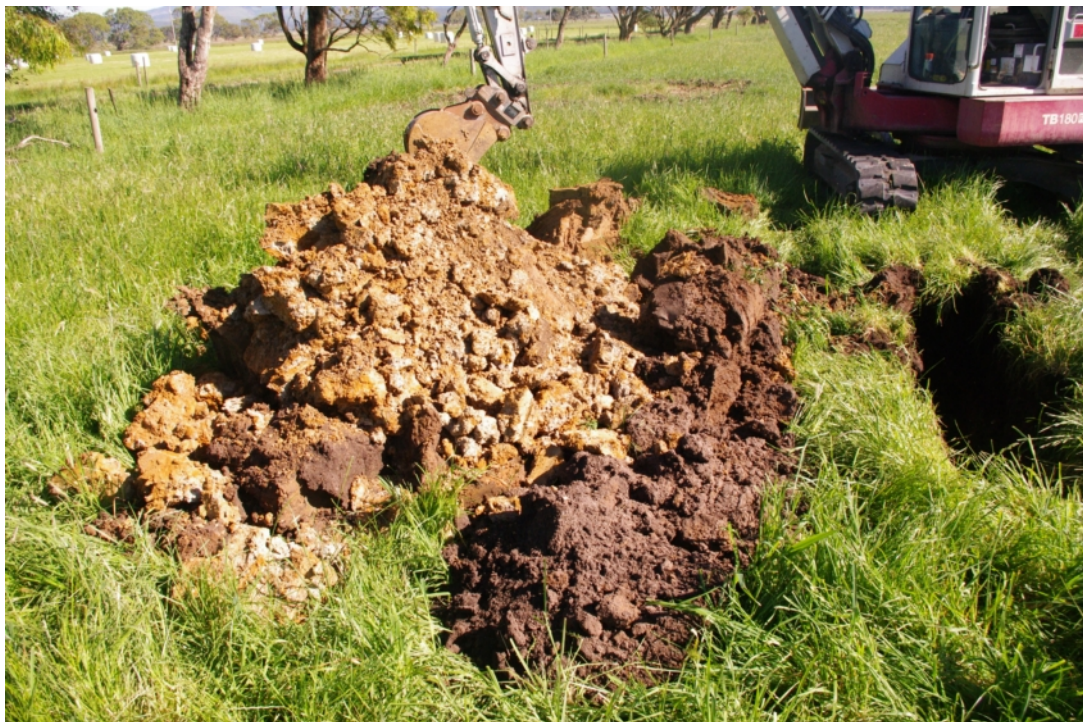
Excavation			Sampling		Field Material Description												
METHOD	EXCAVATION RESISTANCE	WATER	DEPTH (metres)	DEPTH RL	SAMPLE OR FIELD TEST	RECOVERED GRAPHIC LOG	USCS SYMBOL	SOIL/ROCK MATERIAL DESCRIPTION	MOISTURE CONDITION	CONSISTENCY DENSITY	STRUCTURE AND ADDITIONAL OBSERVATIONS	DCP TEST (AS1289.6.3.2) Blows per 100 mm					
												0	5	10	15	20	25
L			0.0				CH	Sandy Silty CLAY high plasticity, dark grey	M		rootlets and organics near surface						
			0.20				CH	CLAY high plasticity, dark grey	F								
EX	M		0.50		0.60 m PP = 150 kPa			orange and pale grey	St								
			1.80 m PP = 200 kPa						M (>PL)								
			2.50		2.50 m PP = 250 kPa			TEST PIT DISCONTINUED @ 2.50 m TARGET DEPTH GROUNDWATER NOT OBSERVED BACKFILLED	VSt								
			3.0

POSITION: Pond Road West
 COORDS: 467624 m E 5729643 m N MGA94 56 (hhGPS)
 SURFACE RL: DATUM: AHD
 LENGTH: 3.00 m WIDTH: 0.50 m
 PIT DEPTH: 2.50 m
 BUCKET TYPE: 450 mm
